Experiences with retro-filling 11kV distribution transformers

Cigre UK A2/D1 R&D Dissemination Day

27th November 2024

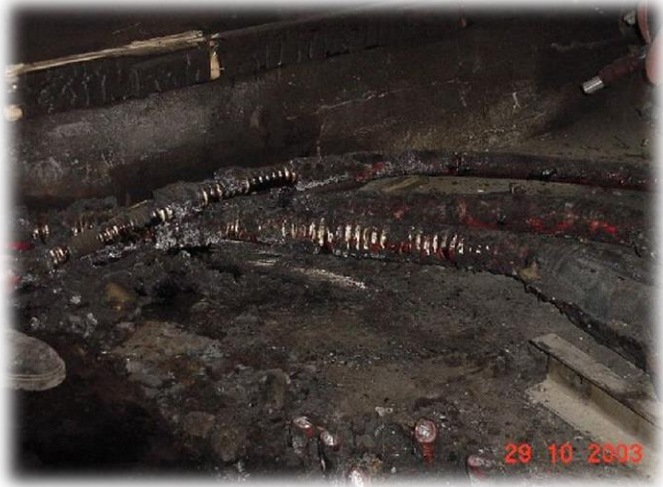
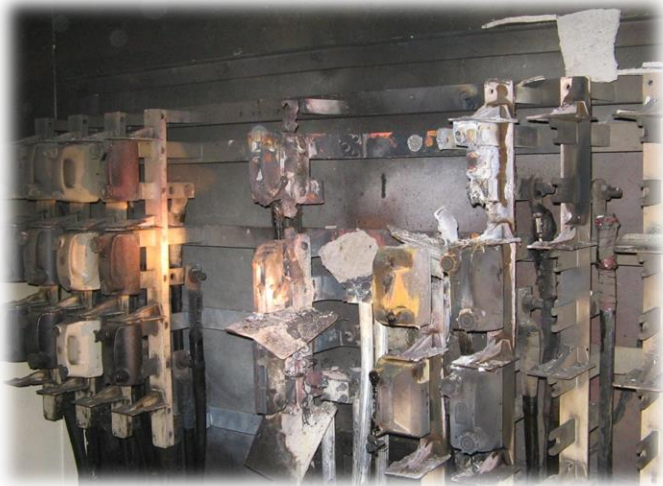
Princess Street, Edinburgh

Both incidents resulted in smoke damage claims from retail shops above

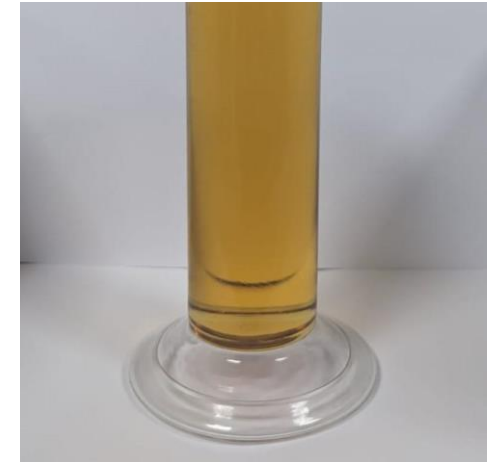
East S/S Transformer

The results for the East S/S samples did not meet the IEC 61203 requirements for fire point. The colour of these samples was orange and much darker than expected. The fire point and density of the samples further indicate that there is residual mineral oil remaining in the sample. K classification is not met for these samples.

- Results highlight the importance of carrying out a good retro-fill procedure and draining as much mineral oil as possible out of the asset.
- The Buchanan Galleries project was impeded by the outage times available due to the shopping centre not wanting to go off supply. Therefore, the whole retro-fill process was carried out in a shorter period than we would normally allow.
- This inevitably was a major contributor with the draining and flushing of the residual oil not being adequate for the Buchanan Galleries East transformer.
- Our experience and test regime indicate that when carried out correctly there is an improvement in insulation resistance test values. Typically, after 3 months following retro-fill the breakdown value improves but there is a rise in both water content and acidity.

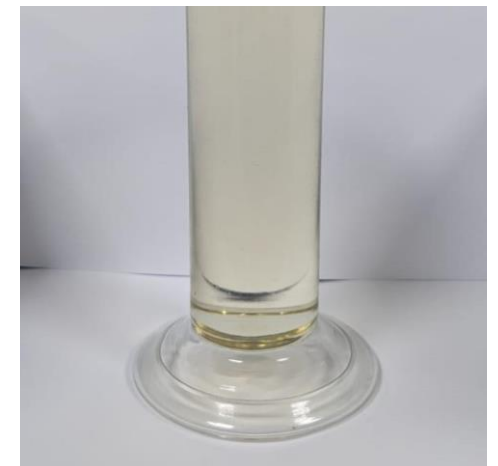
West S/S Transformer

The results for the West S/S liquids tested met IEC 61203 requirements. The flash points of these samples were measured at 244°C and 242°C. These values are lower than expected for pure MIDEAL 7131 however the flash points are expected to diminish with residual mineral oil content.

The flash point of the liquid is more sensitive to contamination and has lower repeatability/reproducibility than fire point measurement. Therefore, the fire point measurement of a sample can be used for in-service samples, as stated in IEC 61203. The fire point of the liquids was 314°C and 308°C indicating that residual mineral oil remaining in the sample was low. K classification is met for these samples
