Electricity Transmission

The age of AI: UK's first trials to develop fully automated overhead line inspection

Presented by Anusha Srihari Arva
CIGRE UK Workshop
21 May 2024

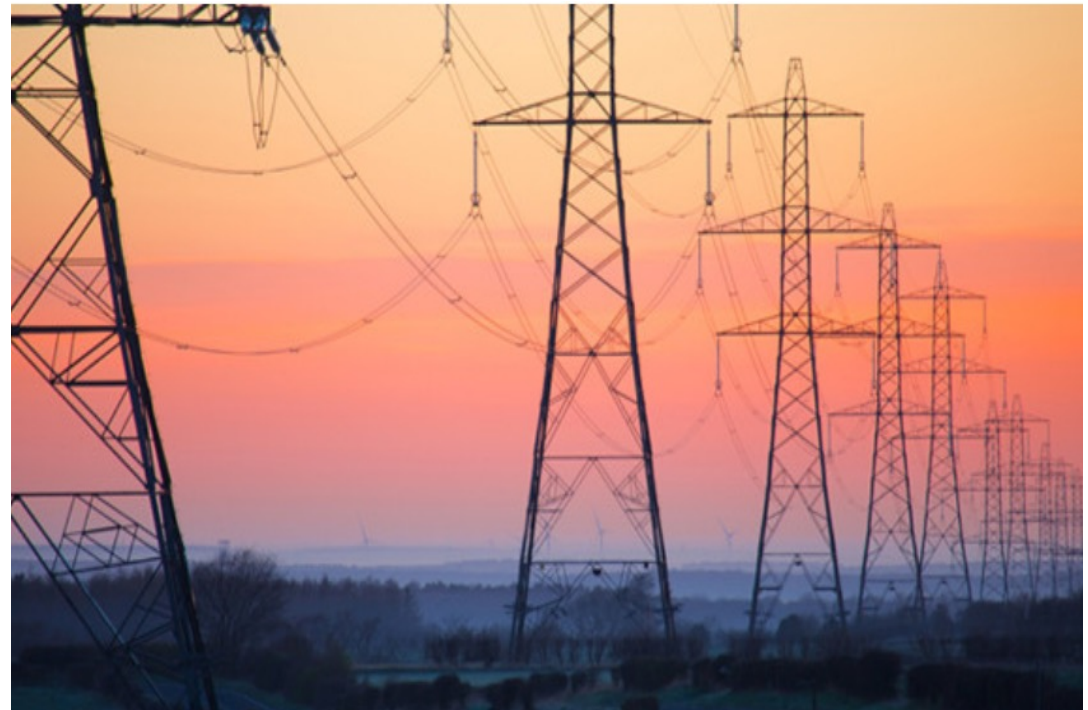
Our overhead line (OHL) network

Power carried at high voltages of 275kV and 400kV through:

- **7,000km of overhead lines**
- **Approx. 22,000 towers (also called pylons):**
 - Lattice structures made of galvanized steel
 - Operating conditions include:
 - Loading: Electrical and mechanical forces
 - Weather: Extreme weather, high pollutant concentrations, wet and coastal conditions

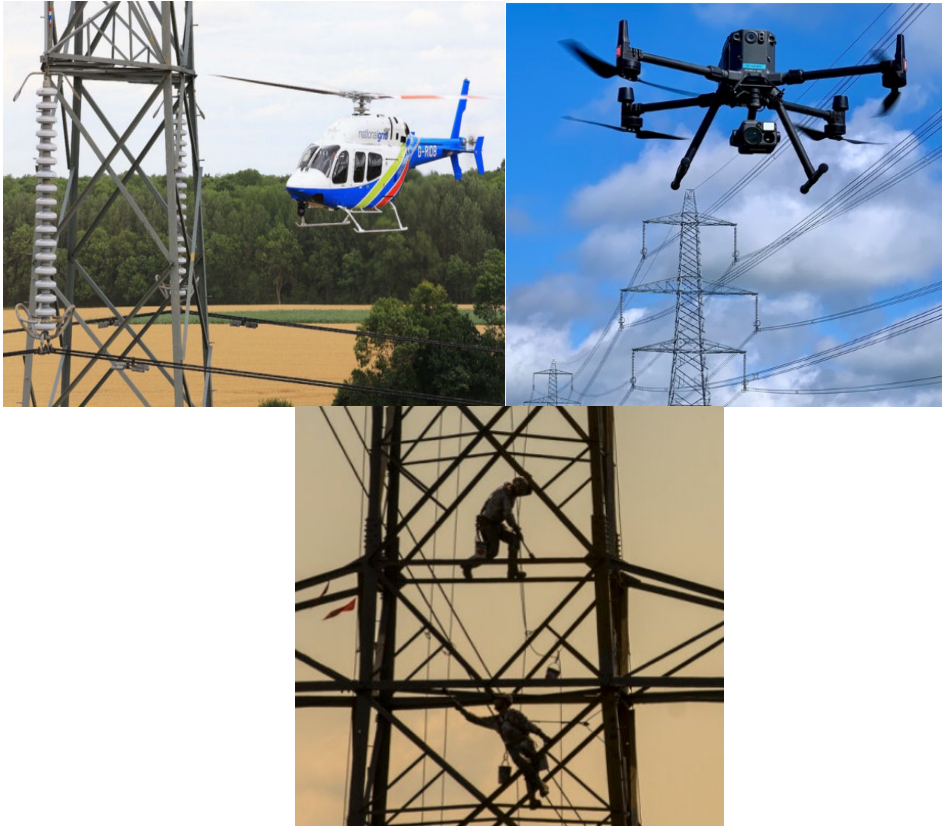
Steelwork condition assessment – data collection

Data collection method	Benefits	Limitations
Helicopter surveys	Cover larger inspection area	Do not allow close quarter imagery, expensive, carbon and noise intensive
Drone surveys	Allow close quarter inspection	Currently cover smaller inspection area and resource intensive due to existing regulation requiring drone pilots on site
Climbing inspection	Precise measurement of remaining steelwork	Not scalable, involves risk

Current annual inspection volume: 3650 towers

Process improvement: Reduce helicopter usage, resource intensiveness of drones to cover larger inspection area to cover future inspection volumes

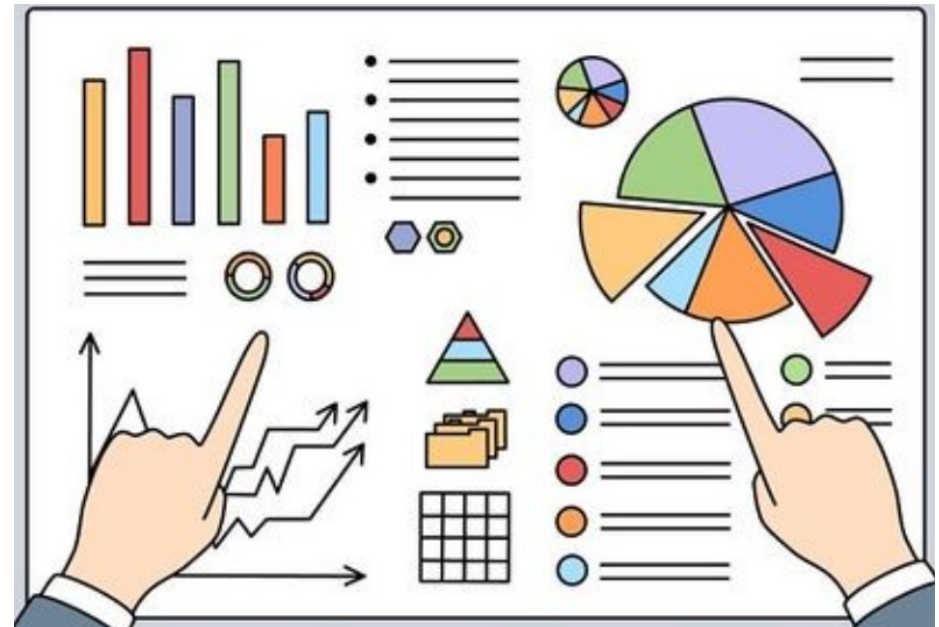
Steelwork condition assessment – data analysis

Data processing of collected imagery:

- Analyzed by a pool of experienced inspectors – roughly 8 towers per hour
- Where grading is marginal, there could be risk of inconsistent assessments – triggering unnecessary additional work/missing necessary ones
- Assessment rate becoming increasingly limited as inspection volumes are projected to scale up

Process improvement: Automate data analysis to be able to cover larger inspection volumes and remove subjectivity

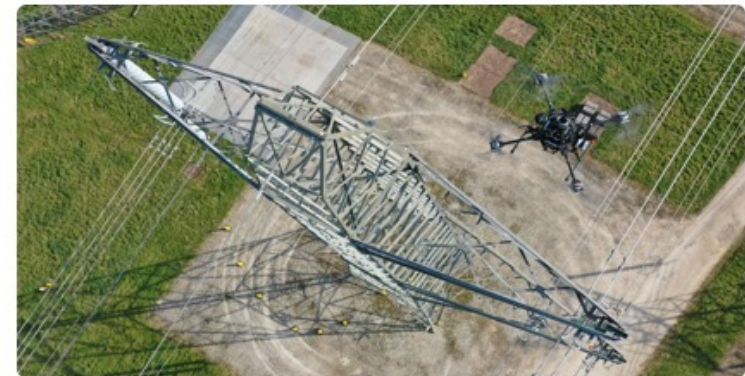
VICAP outcomes: data capture

sees.ai's drone systems

- Adapted to carry out semi-autonomous inspection of transmission towers BVLOS
- Imagery, GPS and LiDAR collected
- Reliable and repeatable results tower-to-tower and flight-to-flight
- Apply for BVLOS permissions for this use case and help lobby CAA for BVLOS policy development

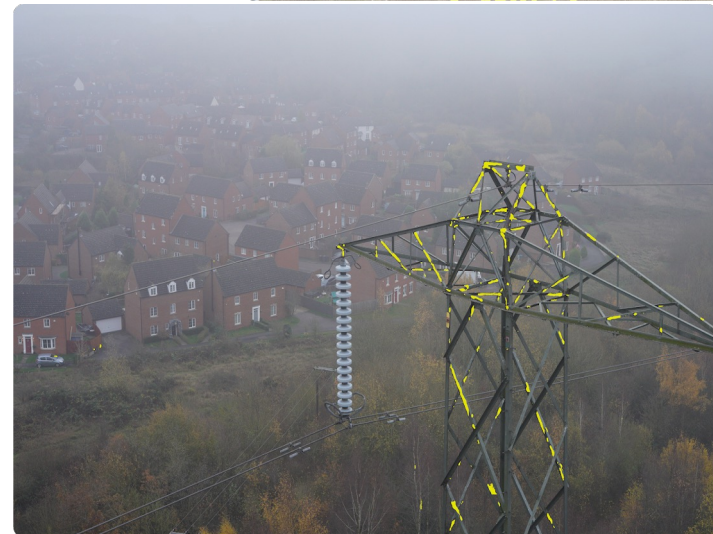
Corrosion segmentation

- AI model automatically detects corrosion using raw or pre-segmented image
- Learns texture and colour
- Tower condition is calculated and broken down by segments

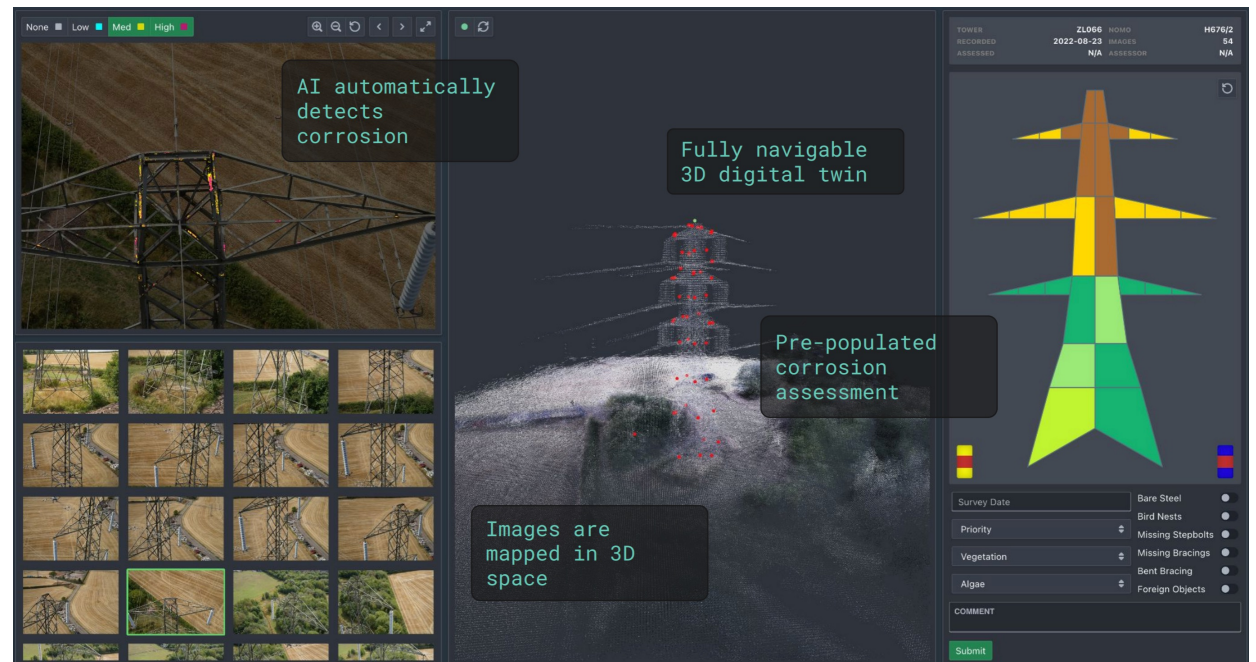
VICAP outcomes: visualization

KeenAI's DeepSteel Platform

- Accurate 3D reconstruction of real environment
- Captured images mapped to real-world position on tower
- Viewable corrosion analysis

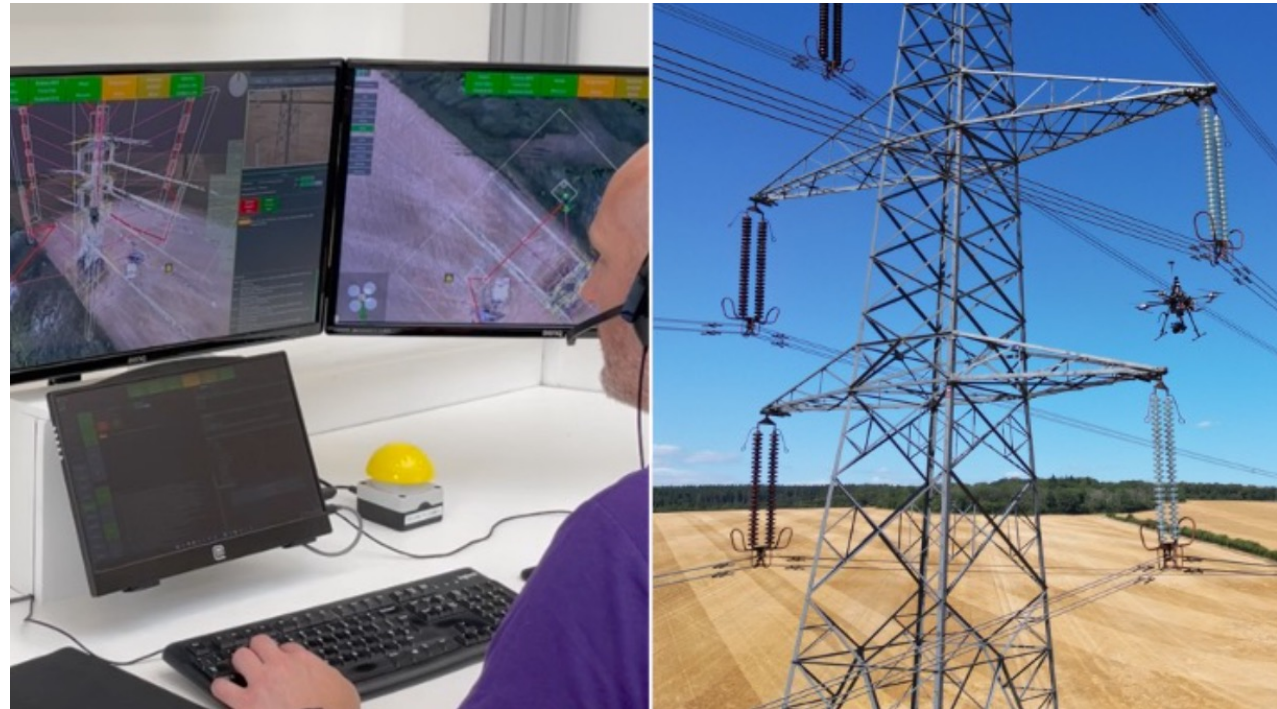
VICAP outcomes: BVLOS permission for OHL inspection

sees.ai secures UK's first routine BVLOS permission to inspect live OHL assets

- Can now fly drones routinely semi-autonomously along 2 specific stretches of our OHL network
- Drones flown and controlled from a remote ground control station – improving the resource intensiveness of our current practice
